XVI. ACCESSIBILITY

STANDARDS AND FINDINGS

C. FINDINGS

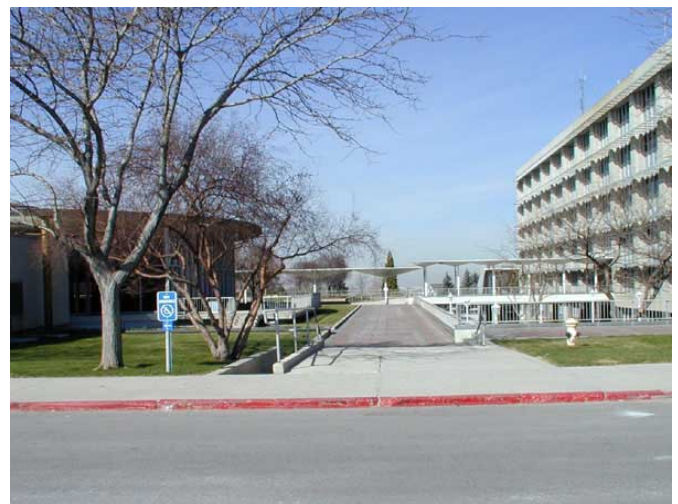
PARKING LOT B AND NORTH PLAZA ENTRANCE

The accessible parking spaces provided in Parking Lot B are too far from the north plaza entrance. Although the North entrance is wheelchair accessible, the distance is estimated to be over 250 feet. When traveling distances are over 100 feet, individuals in wheelchairs or those using canes, crutches or, walkers or those with poor stamina may have to stop and rest for two or three minutes. This can increase a disabled person's exposure to inclement weather (hot or cold) and create periods of severe exhaustion. The picture to your left was not taken from the farthest space, but the traveling distance was estimated from the farthest accessible space.

1. There is a need to clearly define the East Entrance as the intended accessible entrance. This would include using directional signs at site entrances, installing signs on inaccessible entrances, and consolidating accessible parking in sufficient numbers within a reasonable distance from the East Entrance. The decorative poles at the bottom of the access ramp should be removed immediately. This will provide the required 60" deep level landing area. Wheelchair seating can be provided on the center landing of the ramp by relocating the large trash containers.

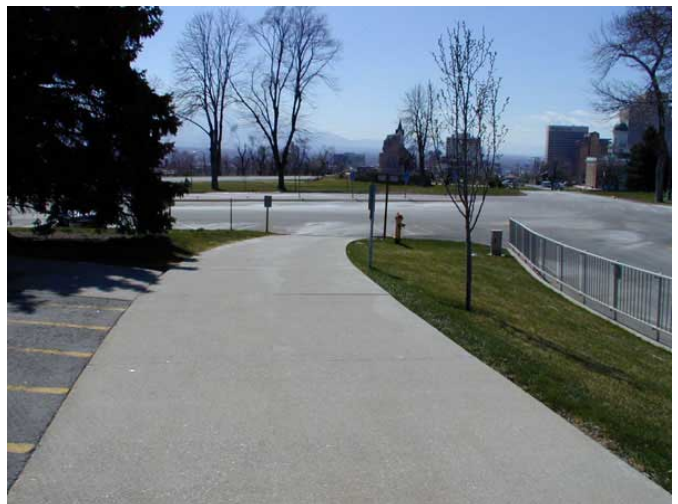
SIDEWALK RAMP

The sidewalk ramp from Parking Lot B to Parking Lot C is not properly marked as not being wheelchair accessible. A warning sign is mounted halfway between the top and bottom of this sidewalk but the sign is not visible to individuals approaching from either Parking Lot B or C. Parking Lot B has more accessible parking spaces and is closer to the East entrance than to the North Plaza entrance. An individual parking in Parking Lot C could easily mistake this sidewalk as the accessible route to the East Entrance. Individuals with disabilities will most often go for the shorter distance. If this sidewalk which has a slope that is greater than 1:20 is retained as is, better signs must be installed. If it is used as an accessible route, it must be treated as a sidewalk ramp and handrails and edge protections installed. The majority of accessible parking spaces should be provided in Lot C.

A warning sign is mounted halfway between the top and bottom of this sidewalk ramp indicating that the sidewalk is not considered wheelchair accessible. Individuals approaching the ramp from either Parking Lot B or C can not easily see the sign.

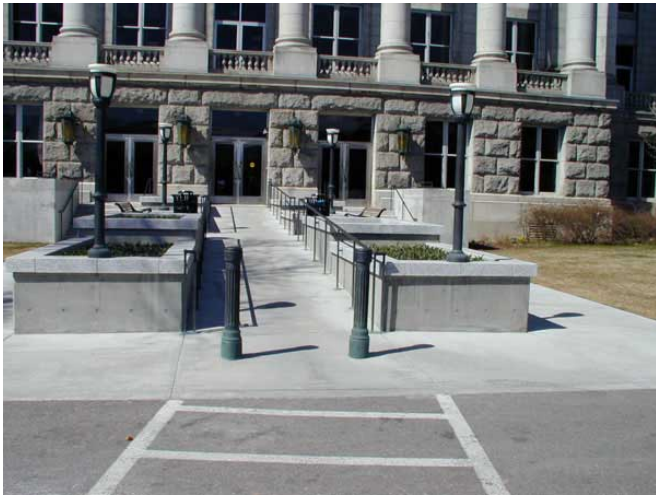
PARKING LOT C EAST ENTRANCE

There are four spaces currently designated as accessible. Of the four spaces, two spaces do not have proper signs. Although the parking lot has a slight slope, a relatively clear accessible route exists from the disabled parking spaces to the East entrance of the Capitol Building. ADAAG 4.1.7(3)(a) and (b), require that only one accessible route and one accessible entrance be provided.

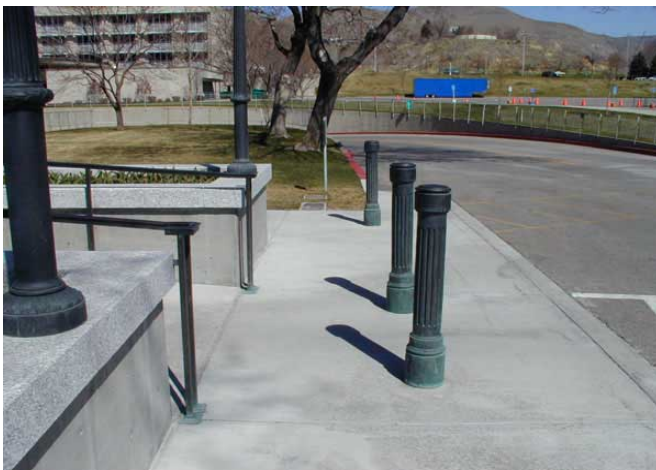
EAST ENTRANCE; BOTTOM OF RAMP

- There is no striped loading zone.
- ADAAG 4.8.4(1) requires a level landing area a minimum of 60" deep at the bottom of any ramp. Landings allow an individual in a wheelchair to maneuver so they can approach a ramp straight on. Due to the decorative poles at the bottom of this ramp, a depth of only 41" is provided.
- Wheelchair seating has not been provided on the center landing of the ramp. Wheelchair seating is a requirement when you offer seating to the general public.

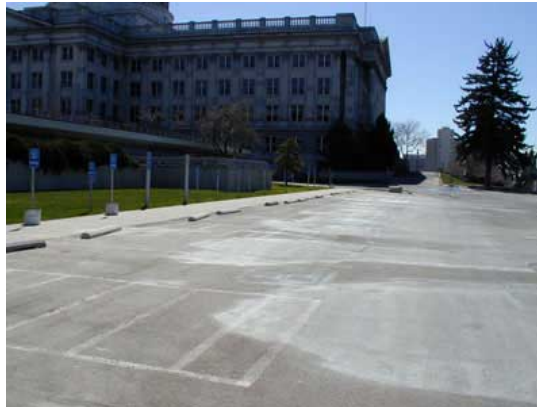
NORTHWEST ENTRANCE ACCESSIBILITY

The three parallel parking spaces marked accessible located at the Northwest Entrance do not meet any accessible parking space design.

There are 12 additional accessible parking spaces on the west side of the parking garage. Five of these spaces do not have access aisles. These spaces appear to be shared by both Capitol and State Office Building visitors. All these spaces are too far from the Northwest Entrance of the Capitol. Due to the location and general appearance of the Northwest entrance we would not consider this an appropriate accessible entrance. In addition, another sidewalk ramp with a slope greater than 1:20 exists between the parking spaces and the entrance.

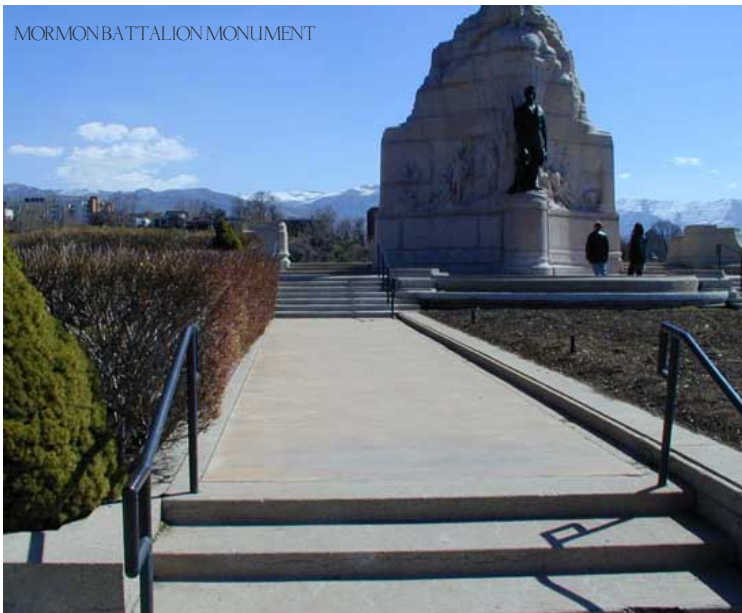
MORMON BATTALION MONUMENT

There is currently no accessible parking near this monument. The slope of the driveway is too steep for a wheelchair to safely access the monument from Parking

Lot C. The monument consists of five levels. Only the first level is accessible by wheelchair.

Making the Mormon Battalion Monument fully accessible will require very clever solutions to avoid negative impacts to this National Register-listed feature.

If it is determined that major structural changes to provide wheelchair access to all levels of the Mormon Battalion Monument would significantly change the look or historical significance of the monument, focus can be directed to items that would not change the historical nature. Simple but meaningful things like creating an accessible route to the seating area overlooking the valley which is currently not accessible or replacing the non accessible water fountain with an accessible one can easily be accomplished. Along with the list of Battalion members, you might consider providing a miniature or a picture of important features of the monument that are not accessible. Parking spaces or a marked loading zone could also be provided. It is not the intent of the ADA to negatively impact historical sites.

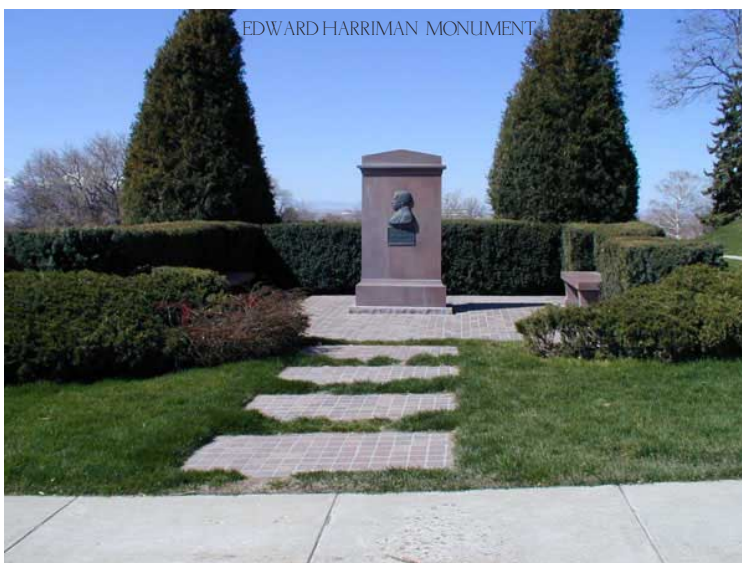
EDWARD HARRIMAN MONUMENT

This monument is not accessible. A stepping stone type path has been used instead of a solid surface path. There is plenty of maneuvering and wheelchair seating space around the monument.

2. Wheelchair access to the front lawn and monument areas can be accomplished with a series of curb ramps and meandering pathways. If monuments can not be made accessible due to plaque height, brochures with the plaque's text can be made available. If seating areas are provided around the monuments for resting or for viewing the surrounding scenery, then adequate paths and space usable by individuals in wheelchairs must also be provided.

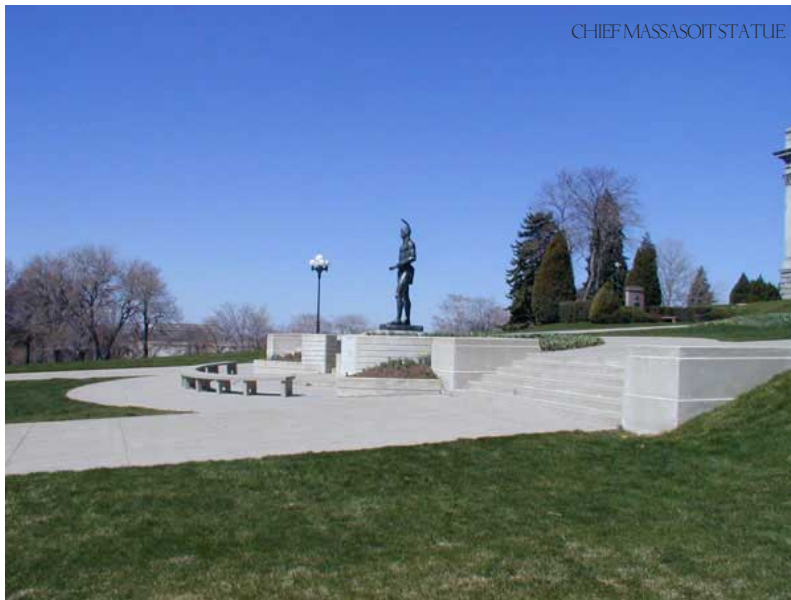
CHIEF MASSASOIT STATUE

A curb prevents complete wheelchair access to this monument.

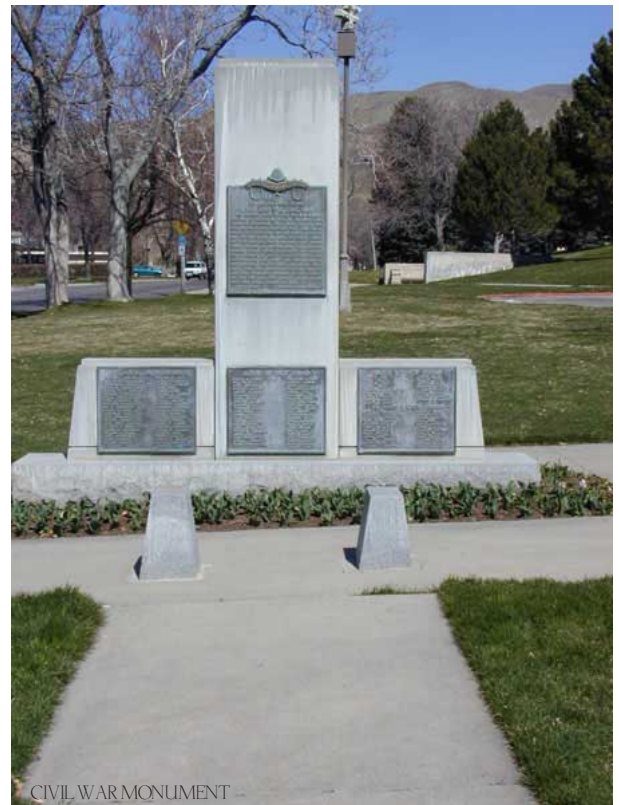
CIVIL WAR MONUMENT

There is no access to the sidewalk from the accessible parking spaces. The monument itself is not accessible because two posts block the entrance. The space between and around the posts is less than 32" wide. A wheelchair could not get to the monument without being forced into the grass.

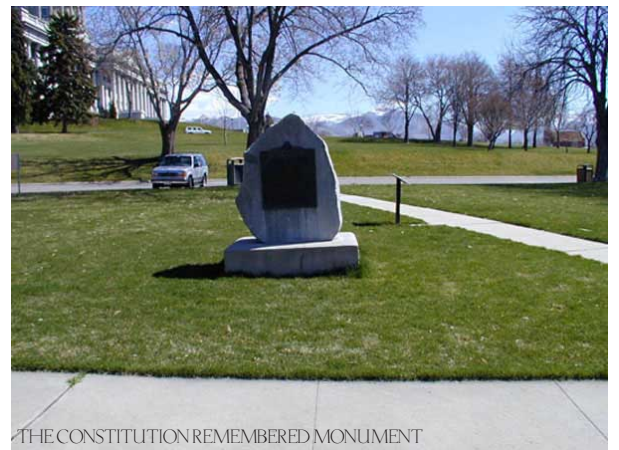
THE CONSTITUTION REMEMBERED MONUMENT

The monument sits out in the middle of a grassy area with no solid surface path from the sidewalk to the monument.

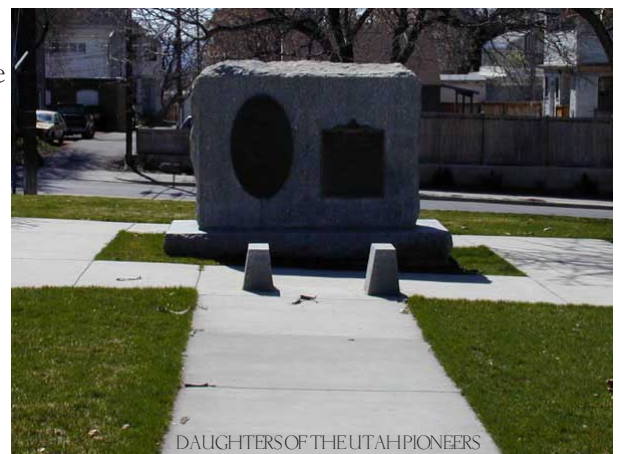
DAUGHTERS OF THE UTAH PIONEERS

There is no sidewalk access from the public or accessible parking spaces. The monument itself is not accessible because two marble posts block the entrance. The space between and around the posts is less than 32" wide.
